Capulli Home Inspections LLC

## Inspection Report

**Property Address:**  
1313 Mockingbird Lane  
Raleigh NC 27616

<b>Date:</b> 1/31/2017	<b>Time:</b>	<b>Report ID:</b> 013117
<b>Property:</b> 1313 Mockingbird Lane Raleigh NC 27616	<b>Customer:</b> Joe Doe	<b>Real Estate Professional:</b> Ken Capulli Fathom Realty

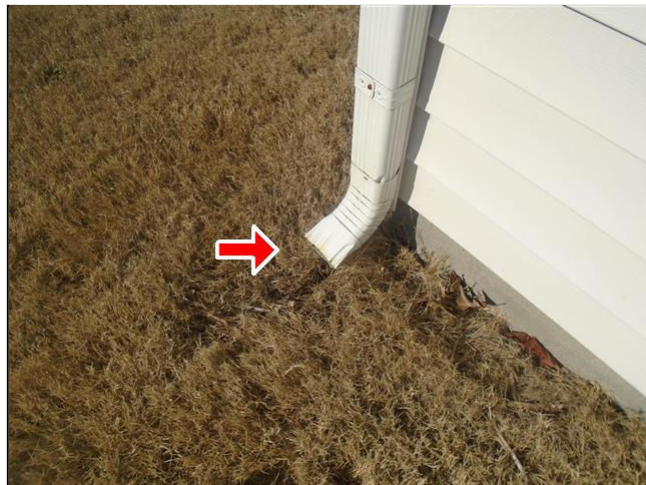
1.3 Item 1(Picture)

**A crushed downspout diverter at the rear elevation needs replacement by a qualified contractor for proper operation**

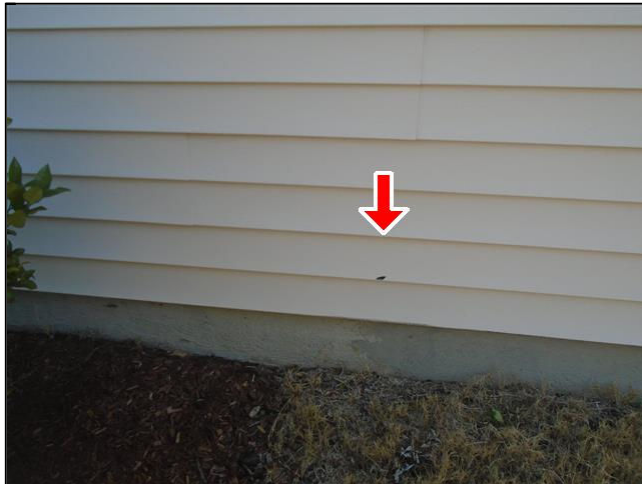
2.0 Item 1(Picture)

**Damaged vinyl siding at the right ( 1 ) and left elevations of house ( 2 ).. I recommend repair by a qualified general contractor to prevent water infiltration that can damage wall sheathing**

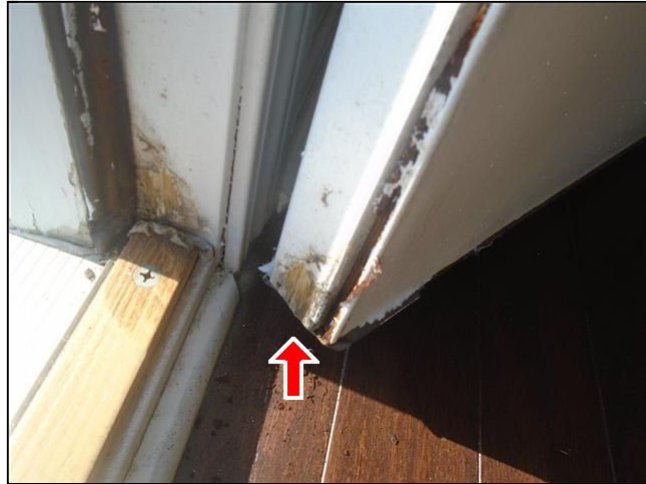
2.1 Item 1(Picture)

The rear French door in the kitchen is corroded at the lower door panels. Further deterioration may occur if not corrected. I recommend evaluation by a qualified contractor to determine the extent of damage and to repair as needed

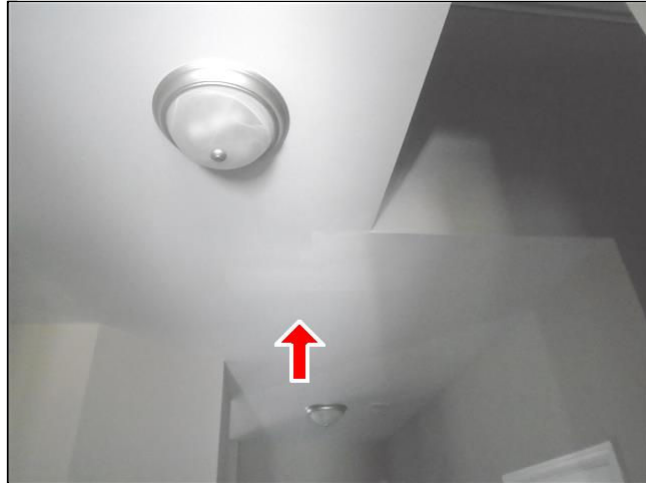
4.0 Item 1(Picture)

**Evidence of repairs were observed at the ceiling at first floor hallway. I am unable to determine cause or reason for repairs. I recommend consulting the seller for more information, Appears to be cosmetic only**

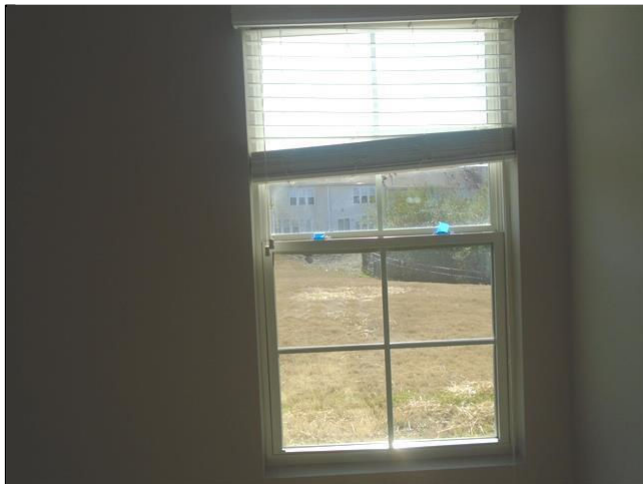
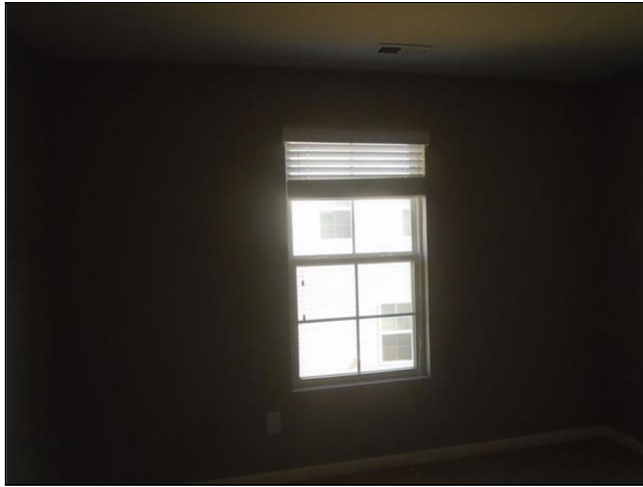
The latches at many window sashes in the house will not engage. This is a security / safety hazard. The sashes may be misaligned. Additionally, many of these same windows are not sitting properly within the tracks. I recommend evaluation of these windows by a licensed general contractor that specializes in window repairs and adjustments for proper operation.

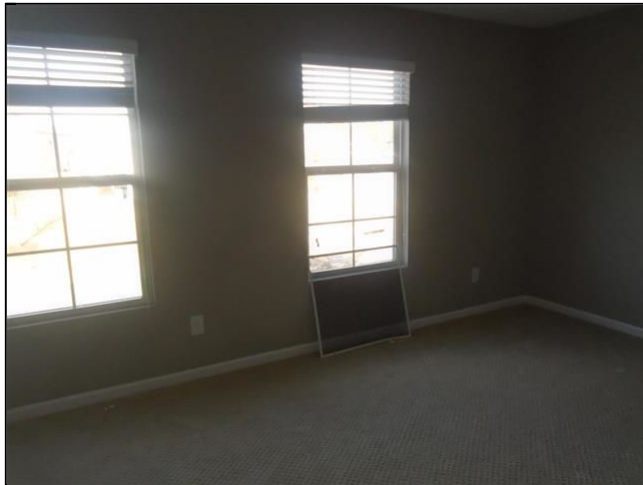
4.6 Item 4(Picture)

The screen at the window in the second floor front left bedroom needs to be installed 4

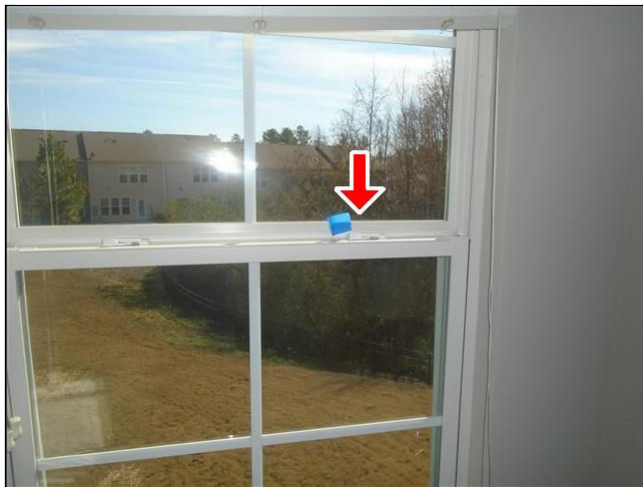
4.6 Item 5(Picture)

The window at the rear wall of master bedroom has a slight cut in the trim, 5

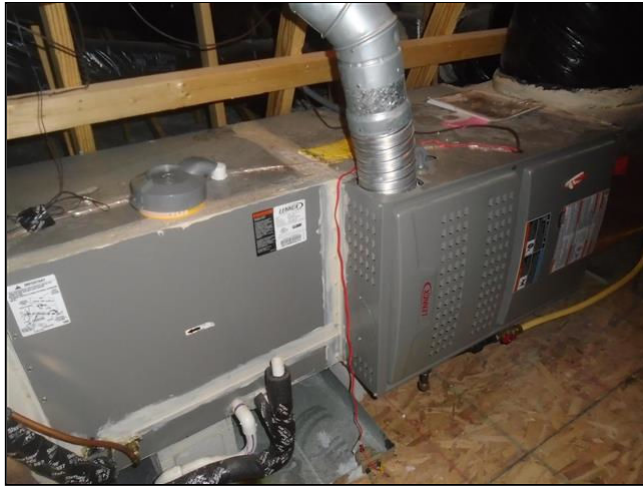
5.6 Item 1(Picture)

The gas furnace is located in the attic 1

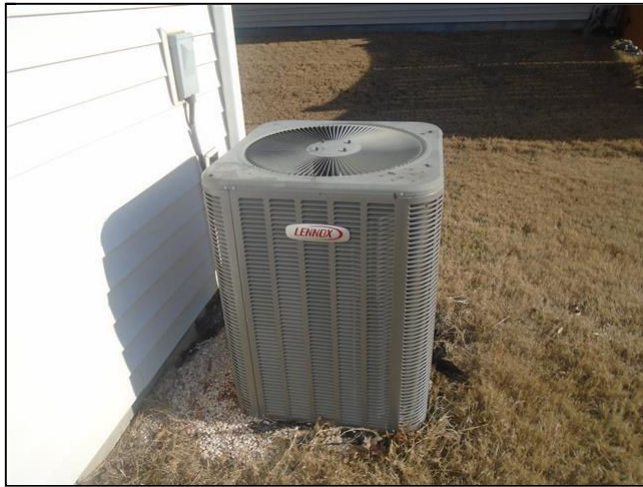
5.6 Item 2(Picture)

The air conditioning unit is located at the rear exterior 2

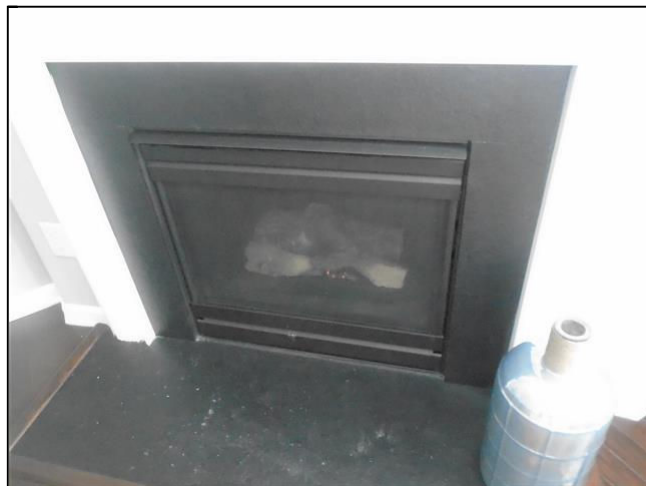
5.7 Item 1(Picture)

The vented gas fire logs were operated and functioned as intended

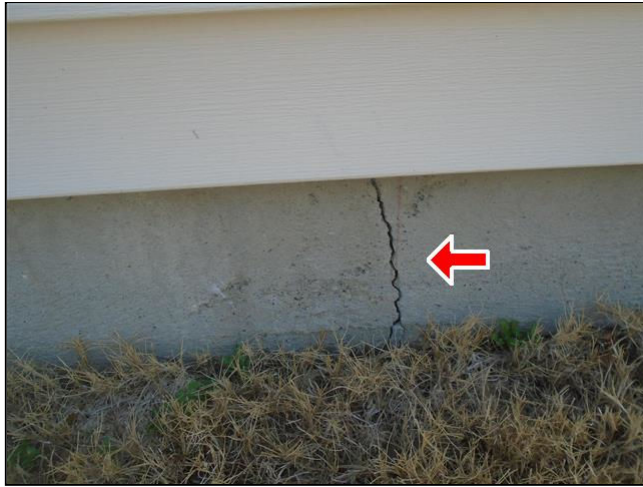
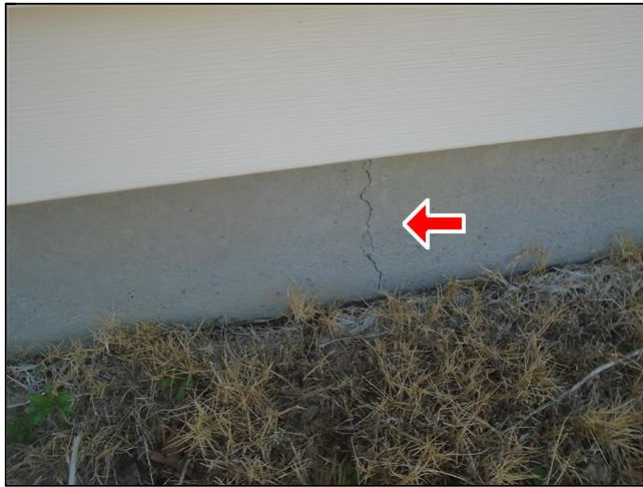
**Vertical cracks in the concrete slab at the right side of home were observed. Many homes have hairline shrinkage or settlement cracks which have no effect on the function of the slab. I recommend that a qualified general contractor evaluate and seal the the cracks to prevent water intrusion which could enlarge cracks . I also recommend monitoring the cracks. If cracks should enlarge , I recommend a qualified structural engineer evaluate to determine if repairs are needed. ( 1-2)**

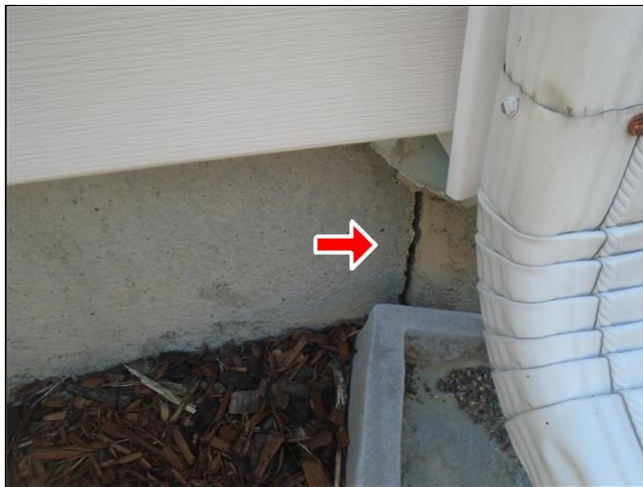
6.0 Item 3(Picture)

**I recommend that a qualified general contractor seal the gap between the foundation slab and the front brick veneer at the left side of house to prevent water intrusion that may cause bricks to loosen over time (3)**

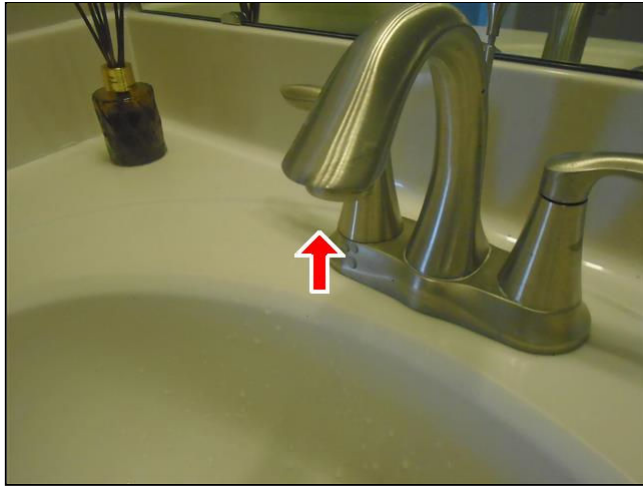
7.2 Item 1(Picture)

**The sink faucet at the first floor bathroom drips. I recommend repair by a licensed plumbing contractor for proper operation 1**

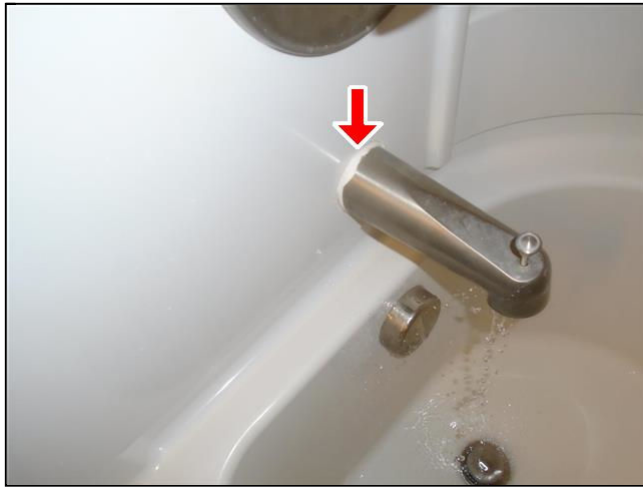
7.2 Item 2(Picture)

**The tub faucet at the first floor hall bathroom is loose and need repair by licensed plumbing contractor to prevent water damage to wall framing 2**

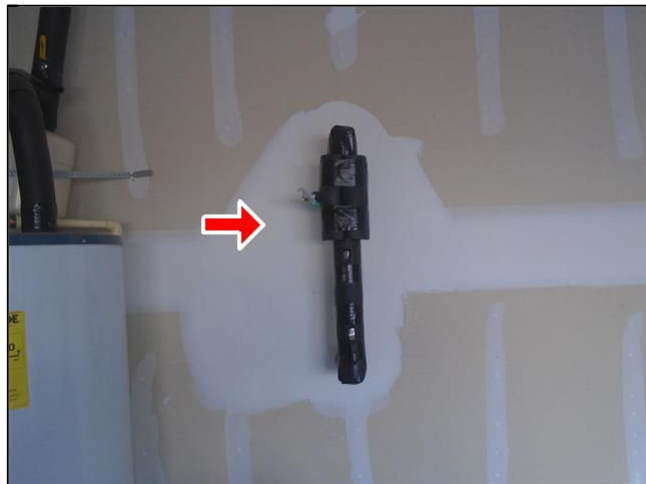
7.3 Item 1(Picture)

The main water shut off valve is located in the garage

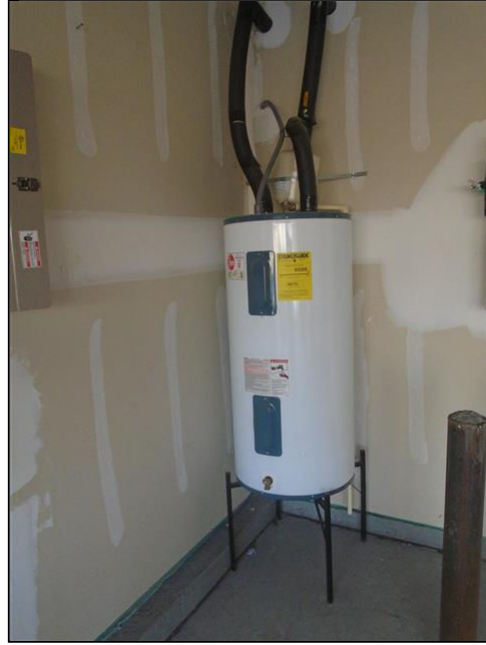
7.4 Item 1(Picture)

**The water heater is located in the garage**

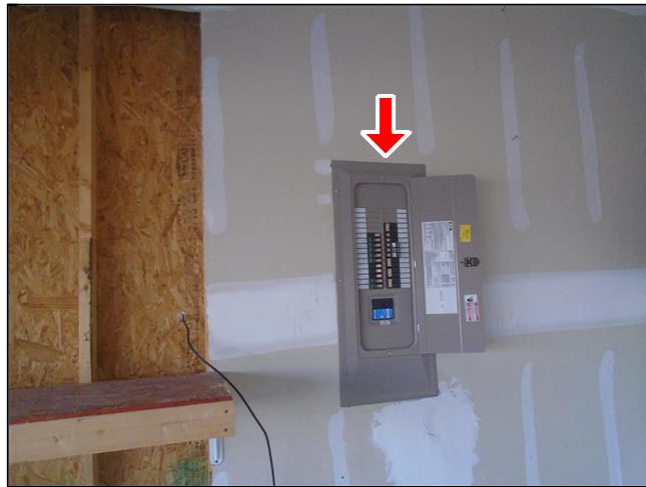
8.6 Item 1(Picture)

The main panel box is located in the garage.

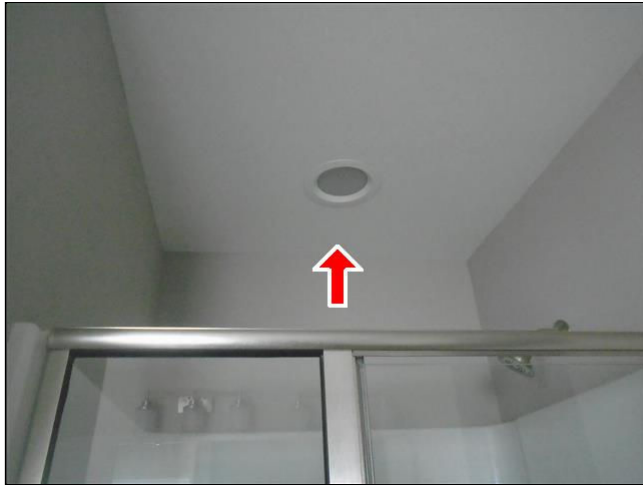
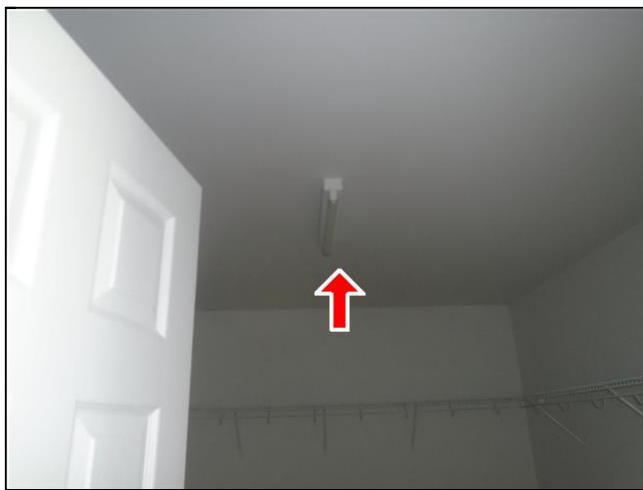
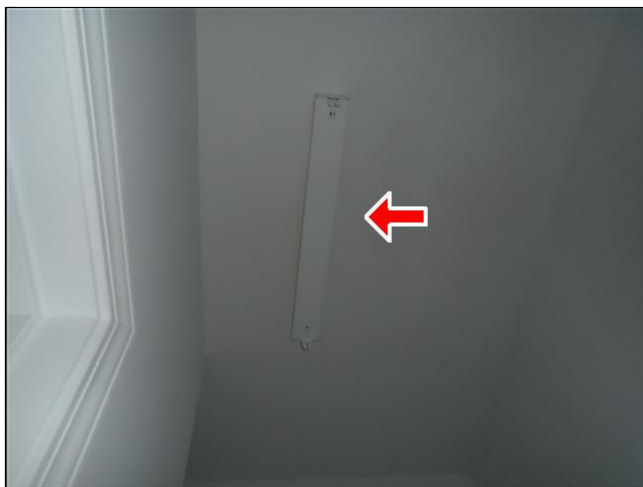
The bulbs at the following locations may be spent or are missing: We recommend replacing the bulbs at these fixtures and confirming operation prior to closing

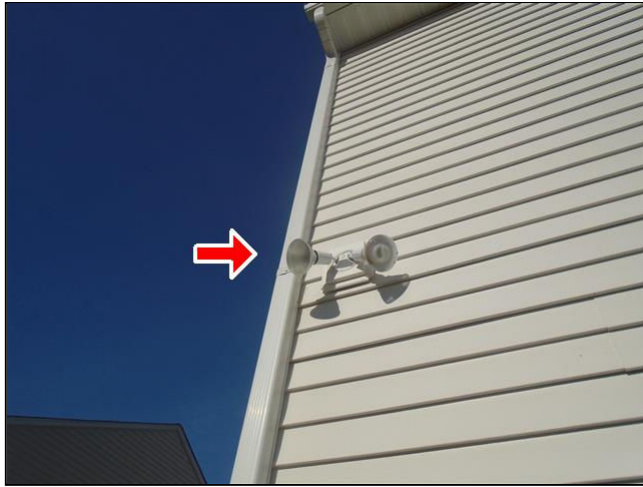
8.11 Item 4(Picture)

at the exterior floodlight fixture at rear elevation ( 4 )

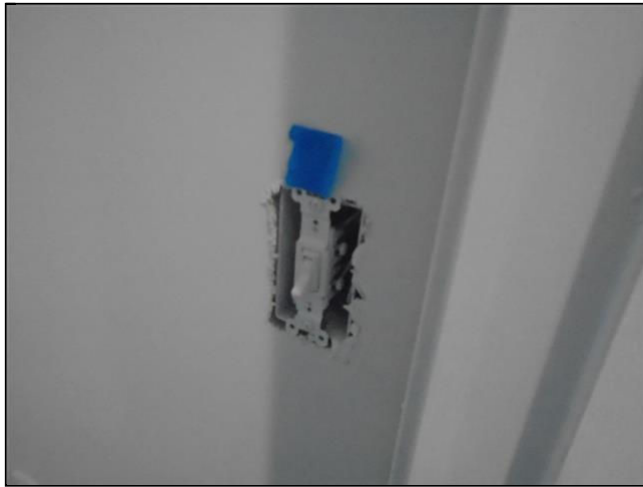
8.11 Item 5(Picture)

The switch plate cover is missing in the kitchen pantry. I recommend replacing as a safety precaution  
5

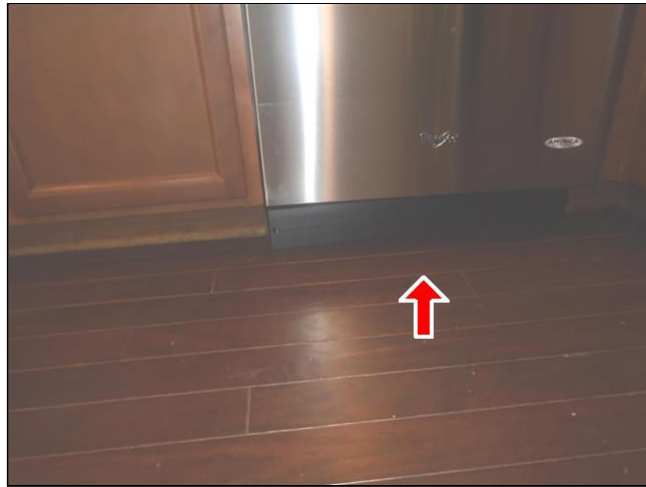
10.0 Item 1(Picture)

The kickplate below the dishwasher is loose. I recommend that a qualified contractor secure for proper operation

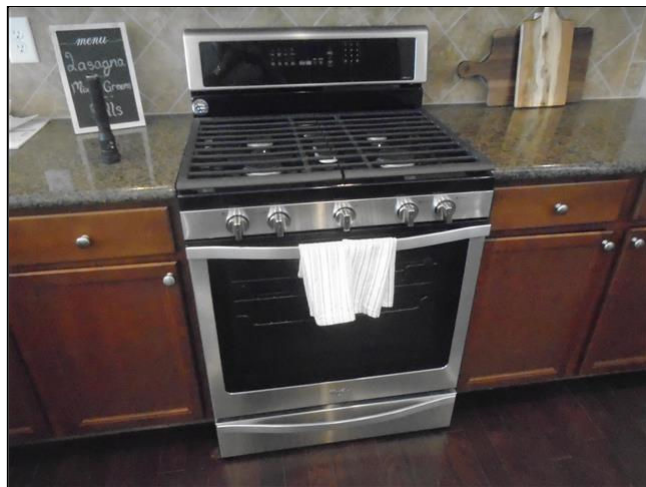
10.1 Item 1(Picture)

The gas stove / oven and electric panel display were none operational at the time of inspection. (possibly not connected at gas line or gas valve is off and display panel may not be plugged in. I recommend confirming operation prior to the end of your dud diligence period

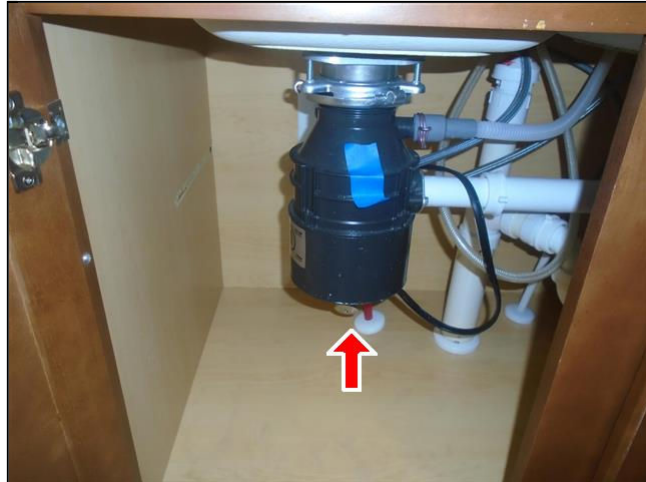
10.3 Item 1(Picture)

The food disposal unit was non operational .( Possibly jammed) I recommend repair or replacement by a licensed plumbing contractor

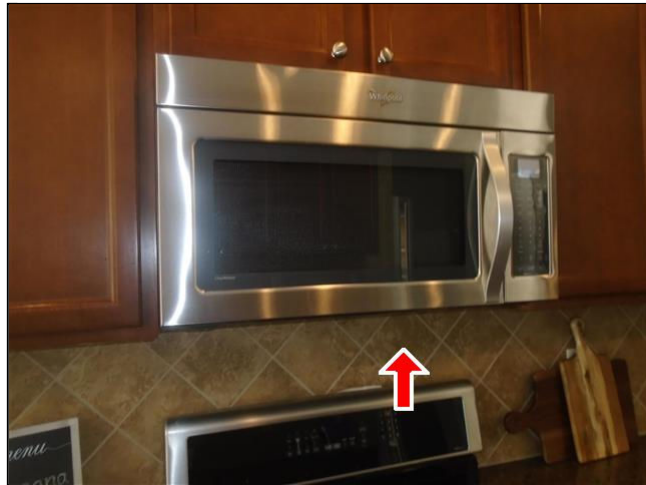
10.4 Item 1(Picture)

The microwave counter light did not work. Possibly a spent bulb I recommend confirming operation prior to closing

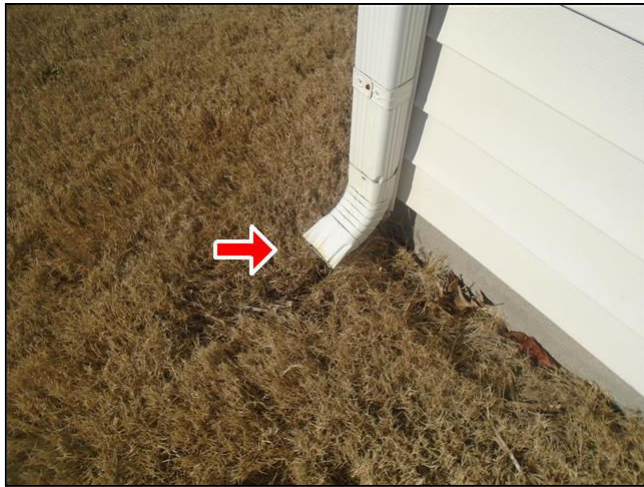
1.3 Item 1(Picture)

A crushed downspout diverter at the rear elevation needs replacement by a qualified contractor for proper operation

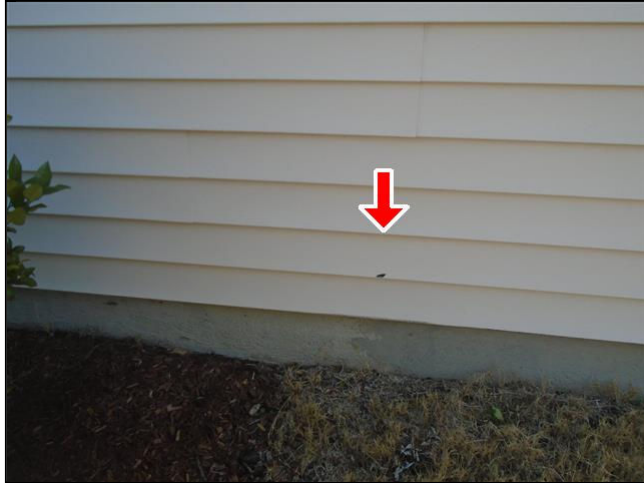
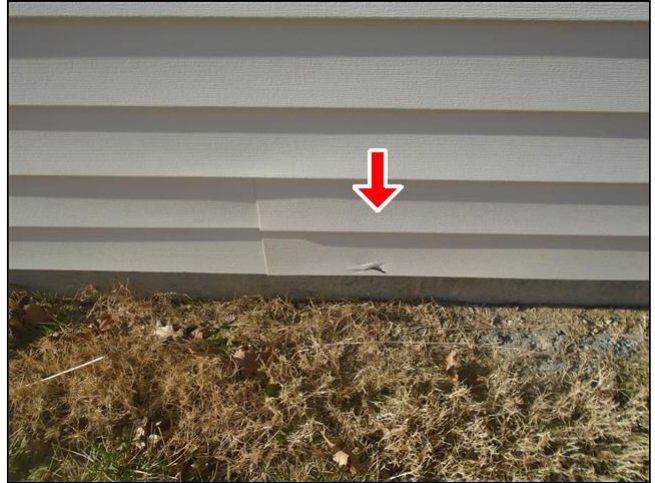
Damaged vinyl siding at the right ( 1 ) and left elevations of house ( 2 ).. I recommend repair by a qualified general contractor to prevent water infiltration that can damage wall sheathing

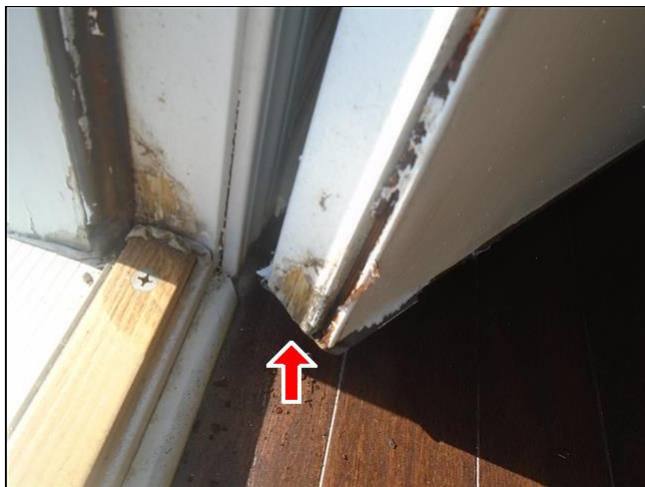
2.1 Item 1(Picture)

The rear French door in the kitchen is corroded at the lower door panels. Further deterioration may occur if not corrected. I recommend evaluation by a qualified contractor to determine the extent of damage and to repair as needed

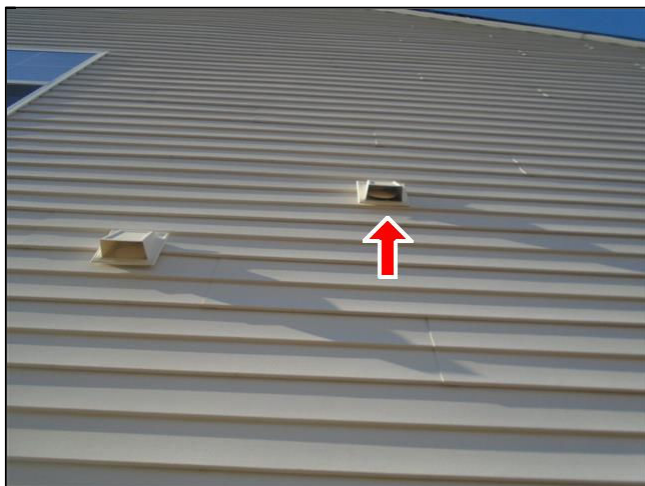
2.4 Item 1(Picture)

The Laundry duct vent cover at the exterior left elevation is clogged with lint. This is a fire hazard I recommend that a qualified contractor remove lint as a safety precaution and proper operation of your dryer.

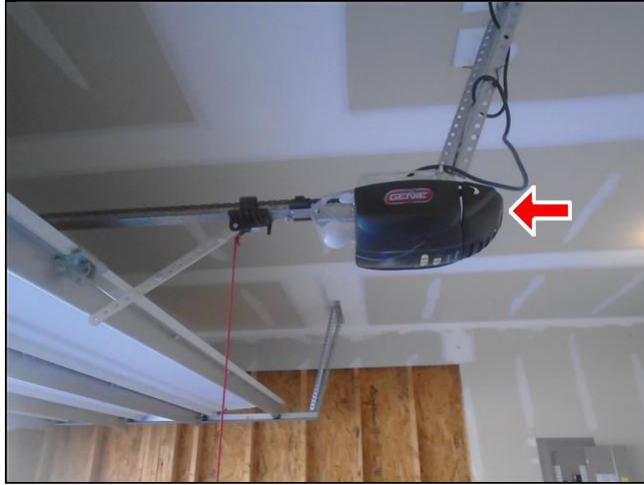
3.5 Item 1(Picture)

Safety reverse did not respond to test, excessive force will damage the top door section. This garage door opener appears to be equipped with a safety reverse device which did not operate when tested. The door would not reverse when met with resistance. Further evaluation by a licensed overhead door contractor for repair as a safety precaution is recommended

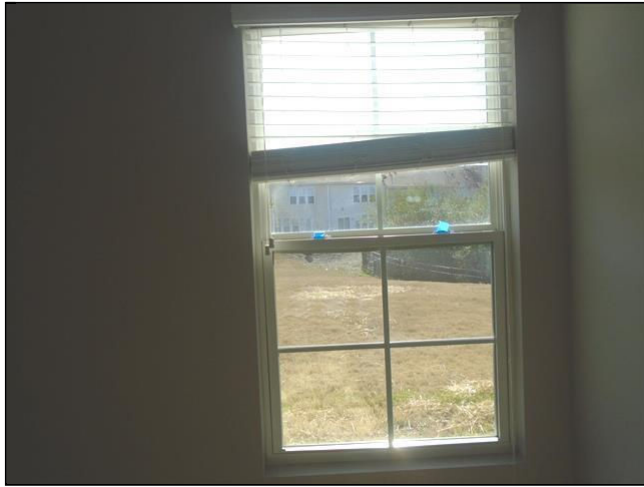
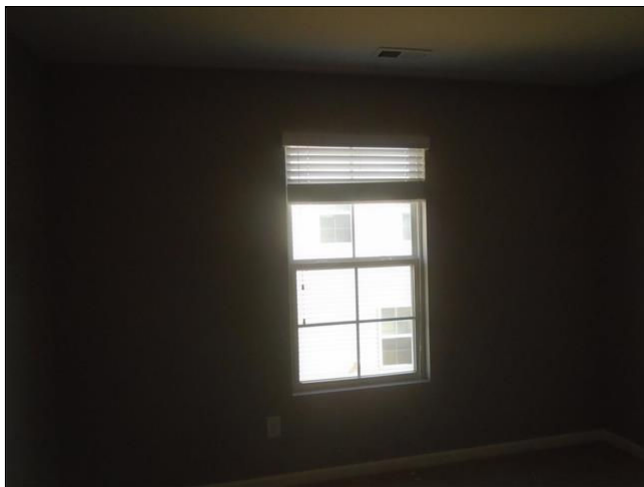
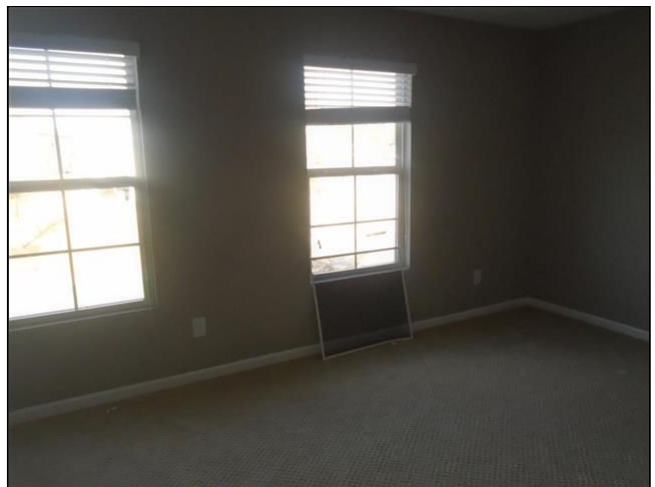
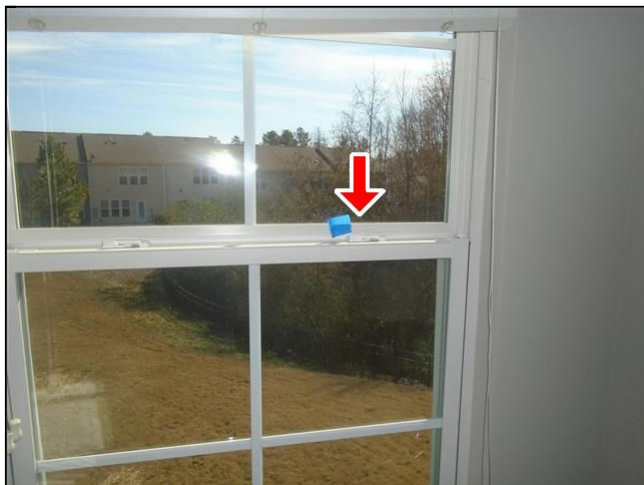
The latches at many window sashes in the house will not engage This is a security / safety hazard. The sashes may be misaligned. Additionally, many of these same windows are not sitting properly within the tracks. I recommend evaluation of these windows by a licensed general contractor that specializes in window repairs and adjustments for proper operation

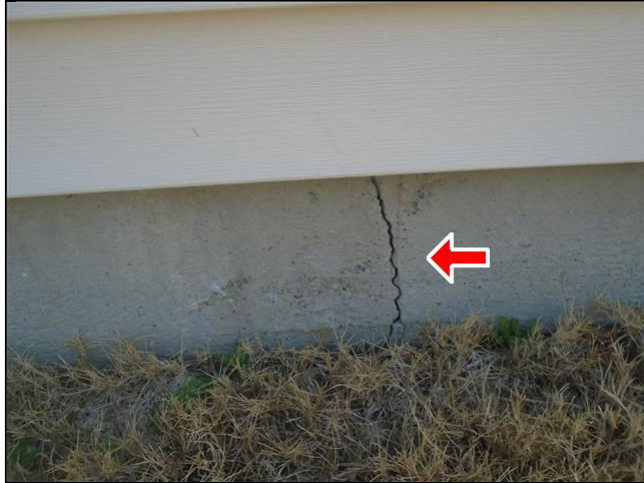
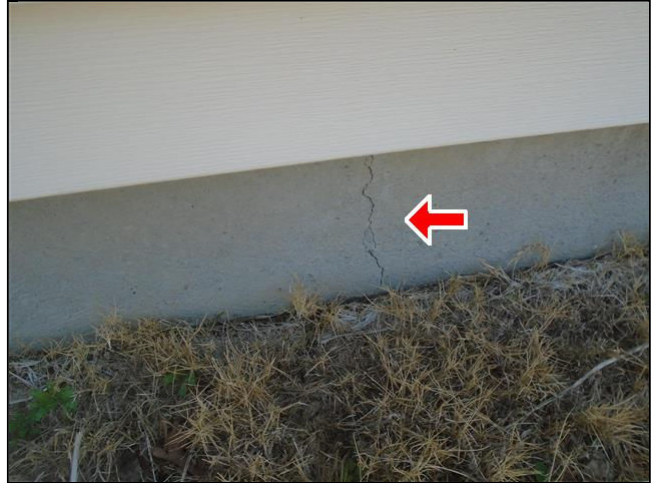
Vertical cracks in the concrete slab at the right side of home were observed. Many homes have hairline shrinkage or settlement cracks which have no effect on the function of the slab. I recommend that a qualified general contractor evaluate and seal the cracks to prevent water intrusion which could enlarge cracks. I also recommend monitoring the cracks. If cracks should enlarge, I recommend a qualified structural engineer evaluate to determine if repairs are needed. (1-2)

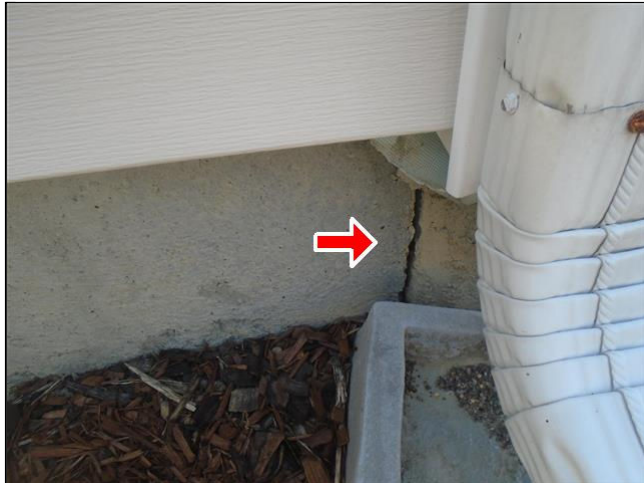
6.0 Item 3(Picture)

I recommend that a qualified general contractor seal the gap between the foundation slab and the front brick veneer at the left side of house to prevent water intrusion that may cause bricks to loosen over time (3)

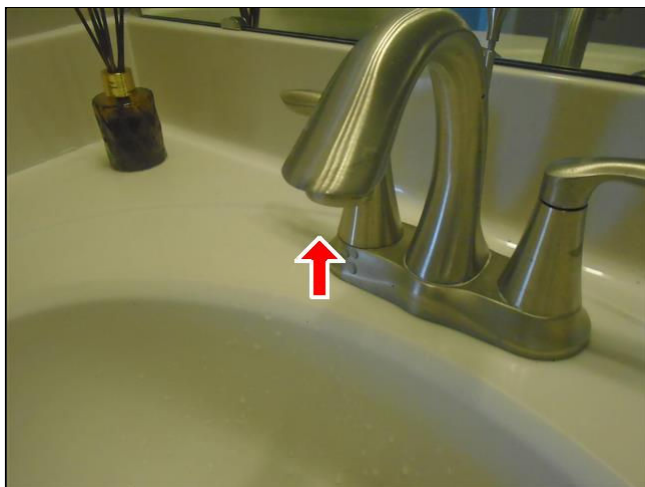
7.2 Item 1(Picture)

The sink faucet at the first floor bathroom drips. I recommend repair by a licensed plumbing contractor for proper operation 1

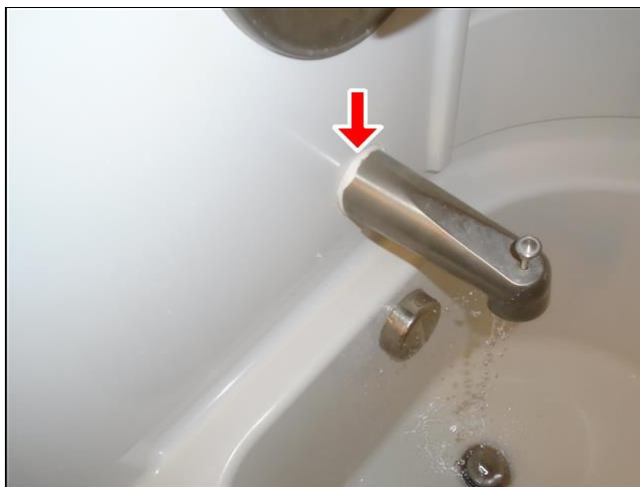
7.2 Item 2(Picture)

The tub faucet at the first floor hall bathroom is loose and need repair by licensed plumbing contractor to prevent water damage to wall framing 2

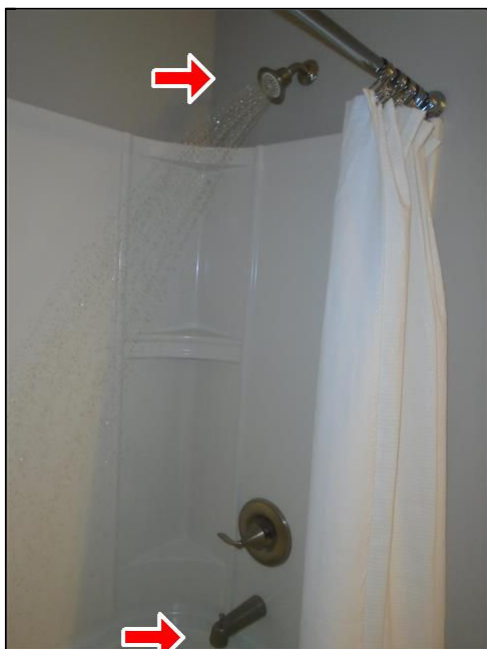
7.2 Item 3(Picture)

The tub faucet at the second floor bathroom remains on after the shower head is activated. This reduces the pressure at the shower head . I recommend repair by a licensed plumbing contractor for proper operation 3

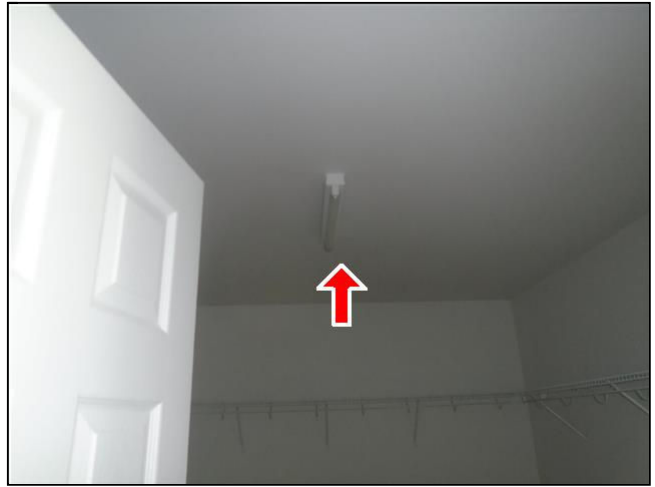
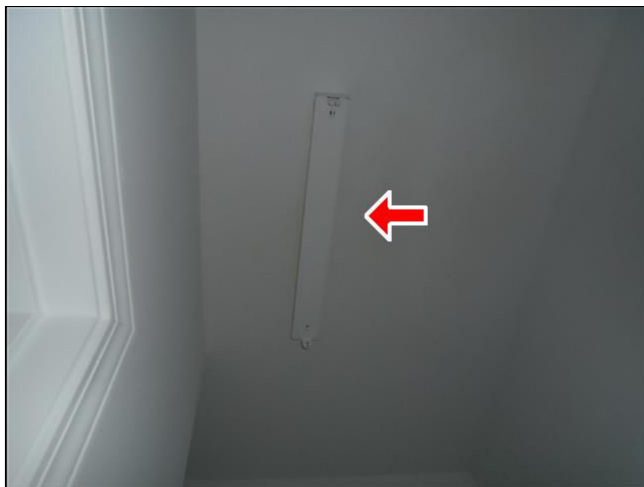
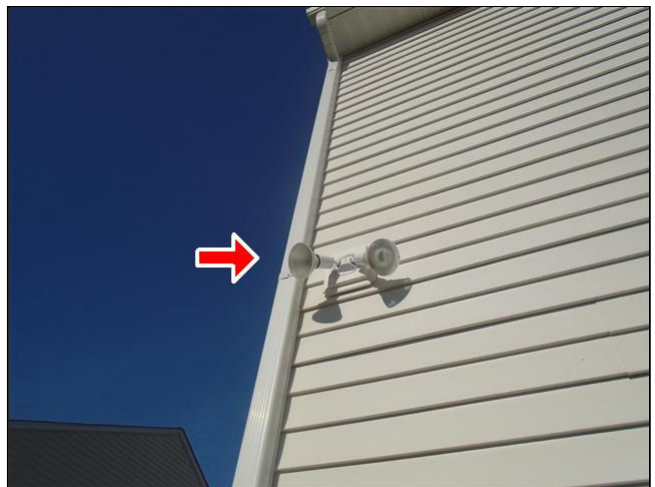
The bulbs at the following locations may be spent or are missing: We recommend replacing the bulbs at these fixtures and confirming operation prior to closing

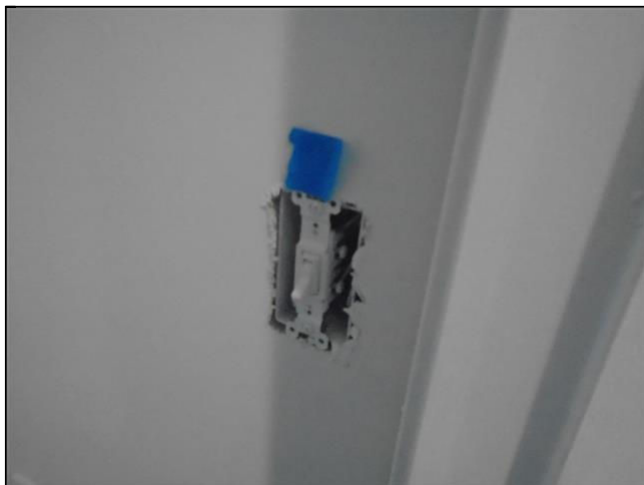
8.11 Item 5(Picture)

The switch plate cover is missing in the kitchen pantry. I recommend replacing as a safety precaution 5

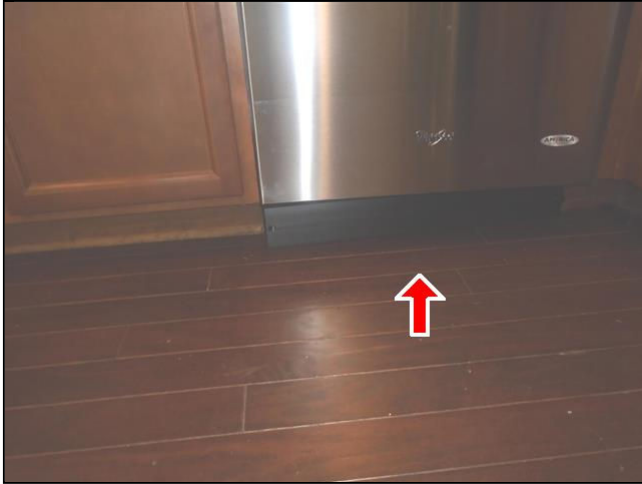
10.0 Item 1(Picture)

The kickplate below the dishwasher is loose. I recommend that a qualified contractor secure for proper operation

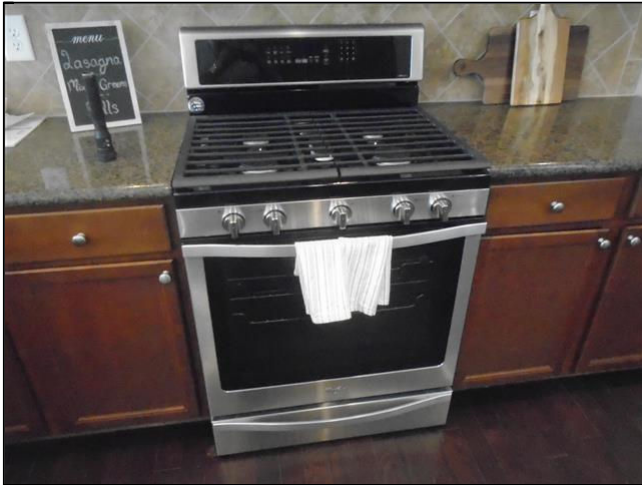
10.1 Item 1(Picture)

The gas stove / oven and electric panel display were none operational at the time of inspection. (possibly not connected at gas line or gas valve is off and display panel may not be plugged in. I recommend confirming operation prior to the end of your dud diligence period

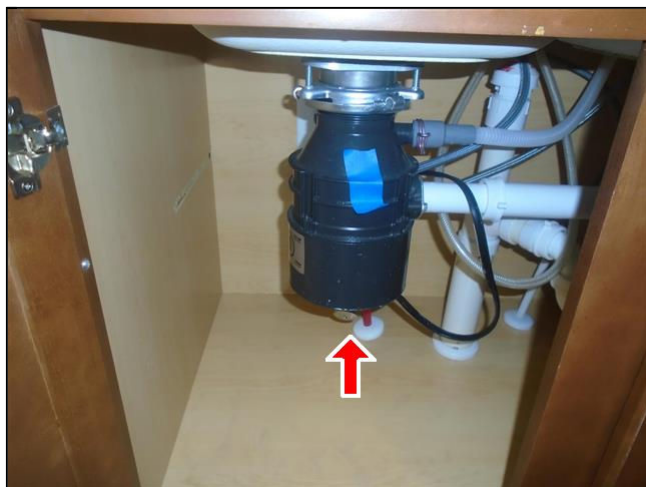
10.3 Item 1(Picture)

The food disposal unit was non operational .( Possibly jammed) I recommend repair or replacement by a licensed plumbing contractor

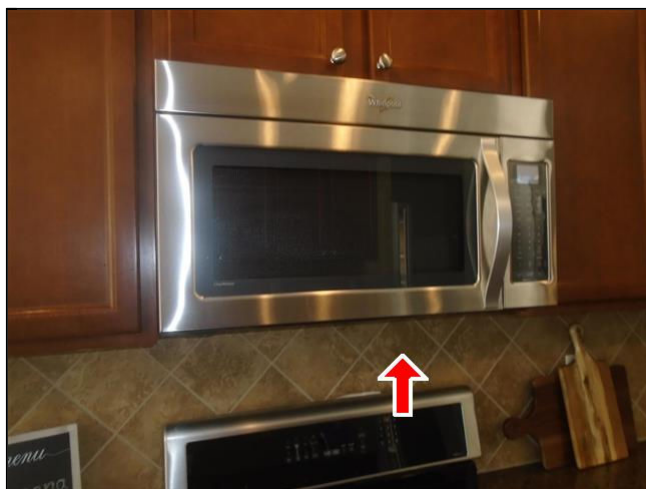
10.4 Item 1(Picture)

The microwave counter light did not work. Possibly a spent bulb I recommend confirming operation prior to closing
